# Manhole Inspection Summary

Manhole # S29K\_\_012MH

Insp Date: **11/24/08 9:00 AM**

**Location** Address: **303 S. Fremont Ave**

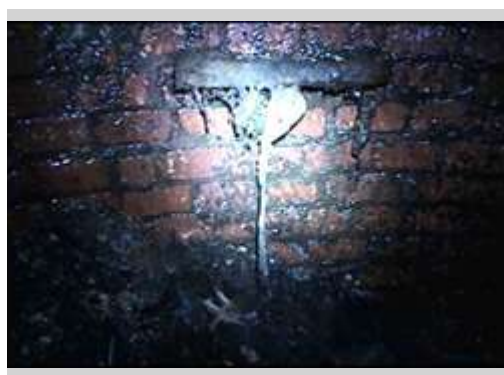
Defect 9

barrel infiltration, evidence of surcharge

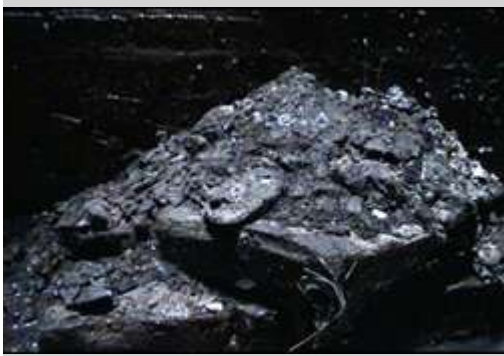
Defect 8

heavy debris and sediment on bench

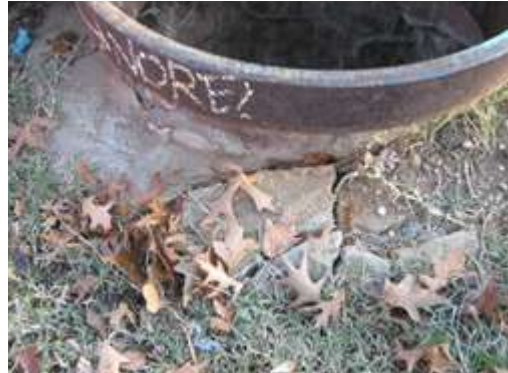
Defect 7

cracked mortar at outside of chimney

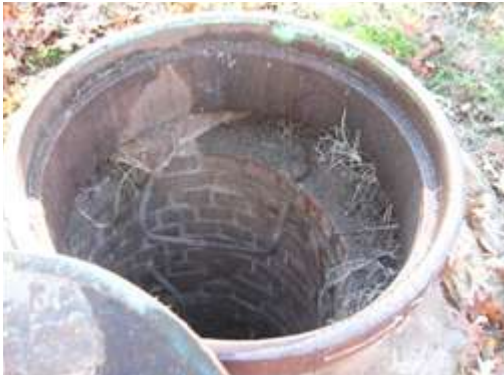
Defect 6

infiltration from the frame

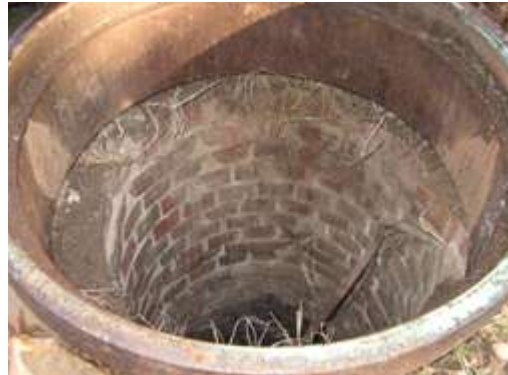
Defect 5

root infiltration at the joint signs of infiltration at wall

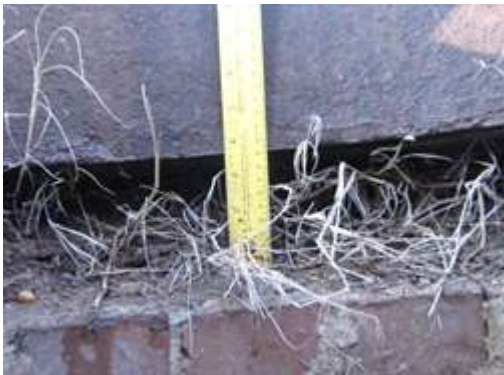
Defect 4

3.5" gap at the joint w/signs of infiltration

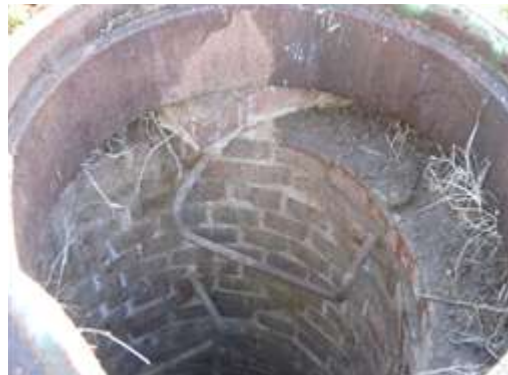
Defect 3

loose bricks and deterioration under frame

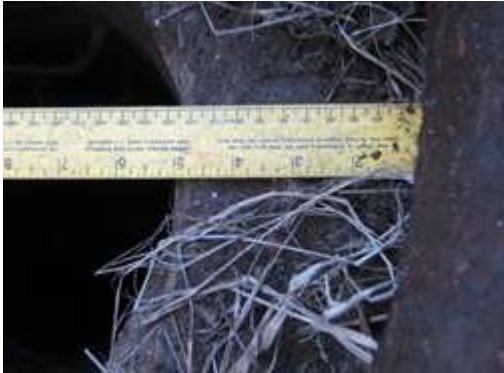
Defect 2

frame offset 5"

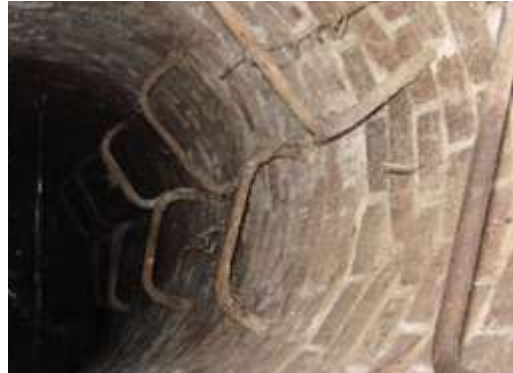
Defect 1

corroded rungs

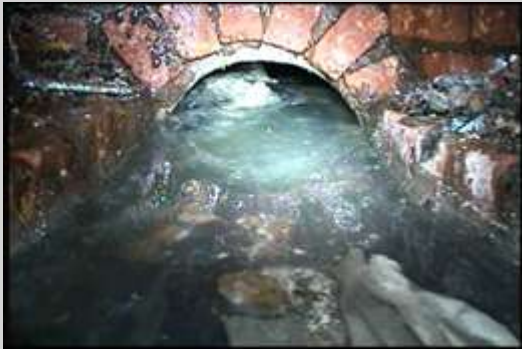
12 O'Clock Outflow

Pipe Height: **10.8** (in.) Rod and Bar (Angled)  
Pipe Material: **Clay** ☐ Pipe Lined  
Invert Depth: **15.89** (ft.) Flow Characteristics: **Fast**  
Deposits: ☐ None ☐ Mud ☒ **Sludge** ☒ **Debris** ☐ Grease  
Silt Depth: **3** (in.) Deposits Extent: **Medium**  
Infiltration: **None** Pipe Seal Cond: **Sound**

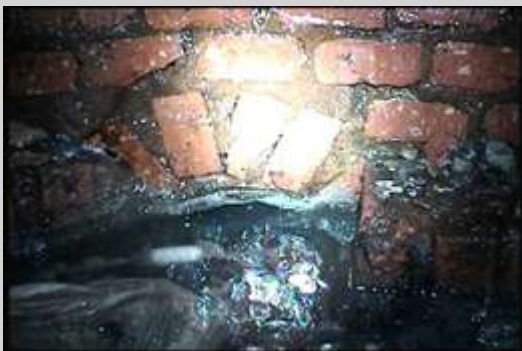
3 O'Clock Inflow

heavy debris in channel

Pipe Height: **4.8** (in.) Rod and Bar (Angled)  
Pipe Material: **Clay** ☐ Pipe Lined  
Invert Depth: **15.70** (ft.) Flow Characteristics: **Slow**  
Deposits: ☐ None ☐ Mud ☒ **Sludge** ☒ **Debris** ☐ Grease  
Silt Depth: **3** (in.) Deposits Extent: **Heavy**  
Infiltration: **None** Pipe Seal Cond: **Sound**

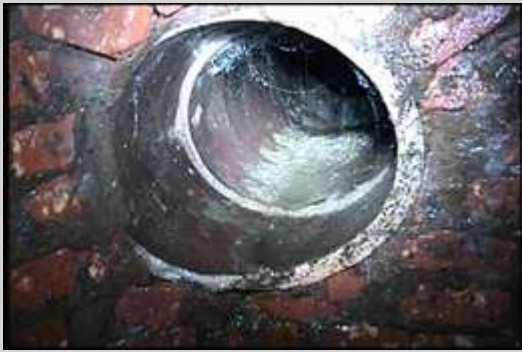
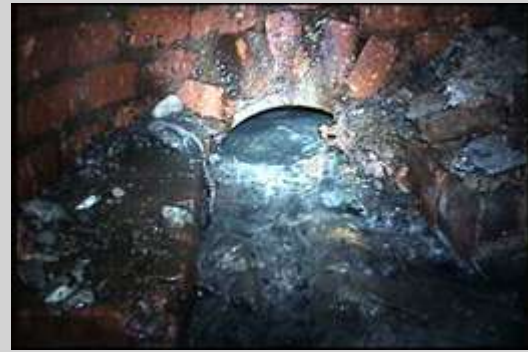
5 O'Clock Inflow

Deposits: ☐ None ☐ Mud ☒ **Sludge** ☒ **Debris** ☐ Grease

Silt Depth: **3** (in.) Deposits Extent: **Heavy**

Drop: **Inside** Rod and Bar  
Angled: **Yes** Reading: **14.67** (ft.)  
Inv Depth: **15.67** (ft.)  
Drop Condition: **Open**

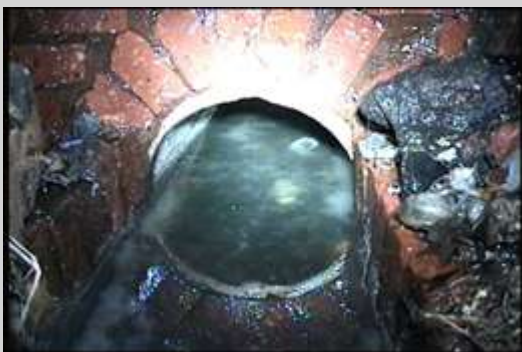
9 O'Clock Inflow

Deposits: ☐ None ☐ Mud ☒ **Sludge** ☒ **Debris** ☐ Grease

Silt Depth: **3** (in.) Deposits Extent: **Medium**
